Brink's Home Inspection LLC Report

Prepared For Exclusive Use By
John Doe

For The Property Located At
0000 River Rd., Toledo, Ohio

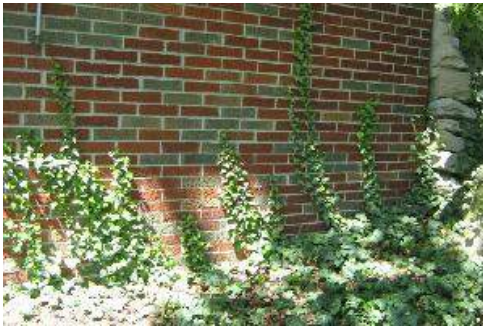
1.3 - COMMENTS: There is foliage growing on or against multiple locations around the residence that we recommend be removed or trimmed back to help prevent damage to the wall coverings.

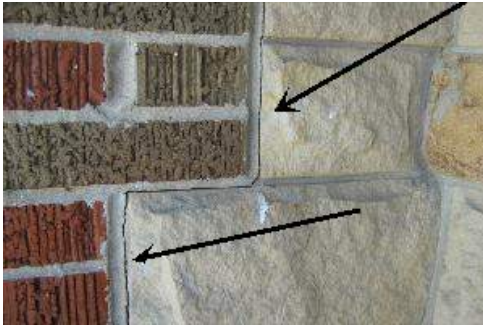
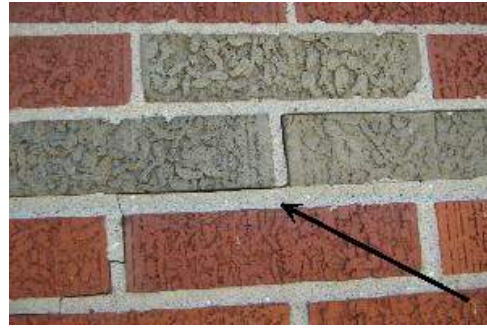
1.10 - DEFICIENT: There is an opening in the brick wall covering at multiple locations around the residence that needs to be repaired to help prevent pest and/or moisture intrusion.

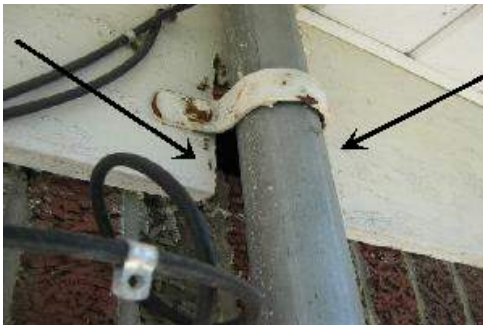
1.11 - DEFICIENT: There are gaps or openings in the wood wall coverings at the right side of the residence that will need to be repaired or otherwise made watertight in order to help prevent against moisture or pest intrusion. This gap is above the electrical service behind the metal conduit.

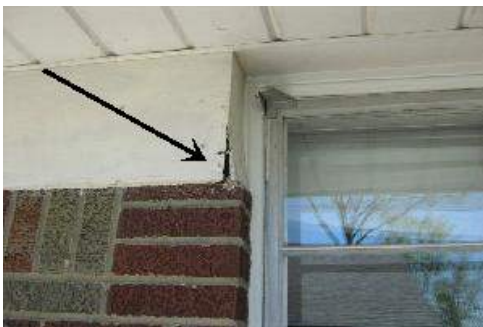
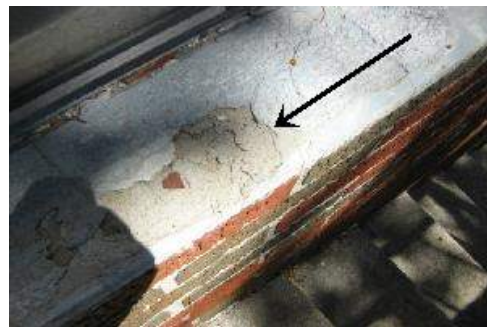
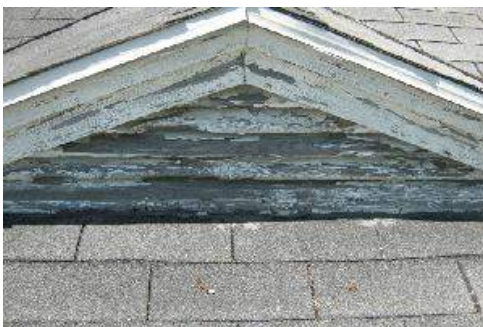
1.13 - MAINTENANCE: Paint loss or deterioration was observed at the wood trim at multiple locations around the residence. We recommend repainting for protection against the elements.

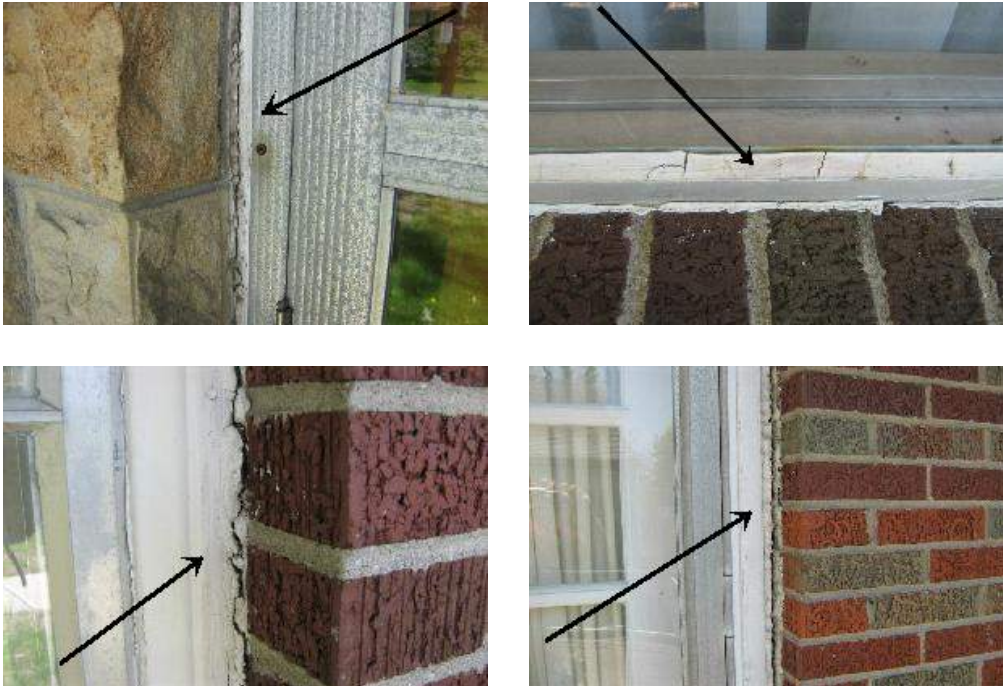
1.15 - MAINTENANCE: The door and window exteriors at multiple locations around the residence are in need of maintenance-type service such as sanding and painting or refinishing.

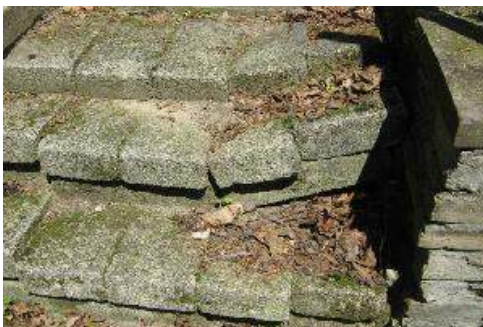
1.18 - SAFETY: The treads and risers at the stone stairs at the back side of the residence are not uniform and could prove to be a trip-hazard if this condition is not corrected.

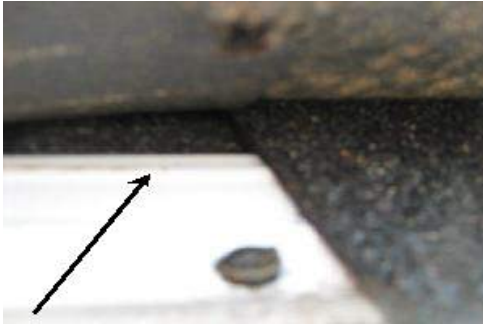
3.3 - MAINTENANCE: The roof has two layers of roof coverings, composition shingle over composition shingle, which can reduce the lifespan of the top layer of shingles.

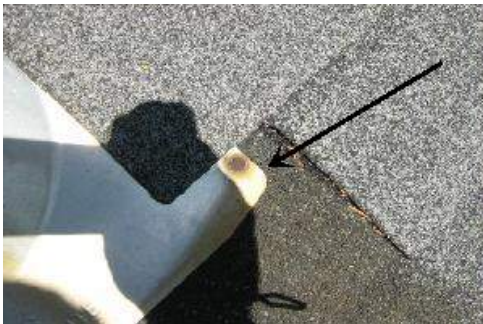
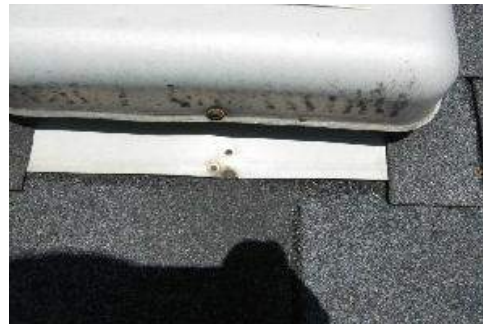
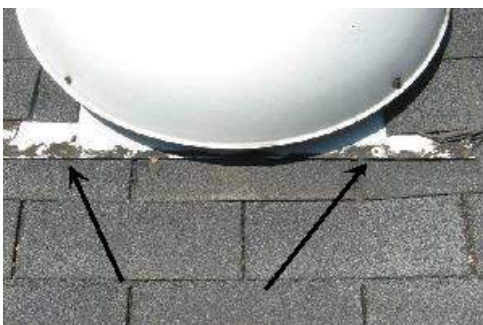
3.4 - MAINTENANCE: Exposed nails in various locations on the roof should be addressed and sealed with the proper roof sealant or exterior caulk

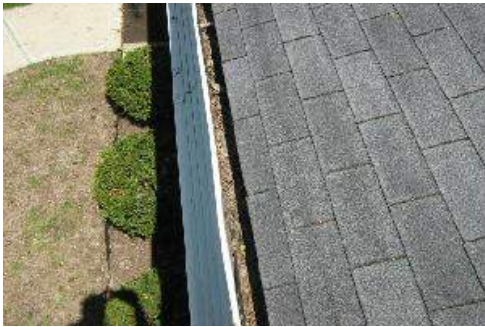
3.7 - MAINTENANCE: The roof gutters need to be cleaned and serviced to perform properly.

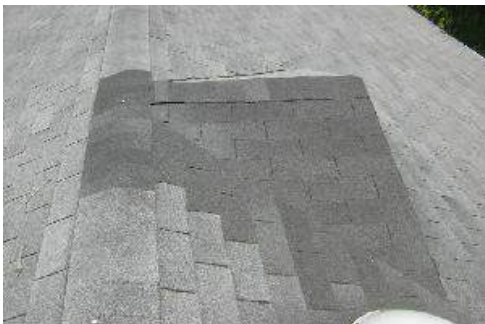
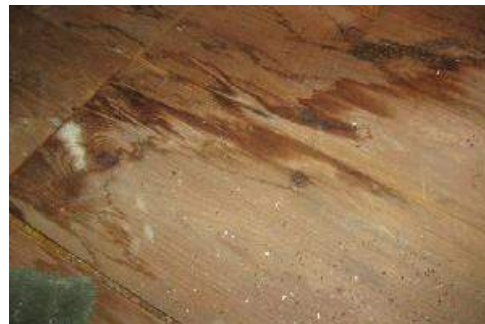
4.4 - PREVENTIVE: There are moisture stains and/or sufficient evidence of prior roof leakage inside the attic, which should be evaluated by an appropriately qualified specialist for further remarks and recommendations.

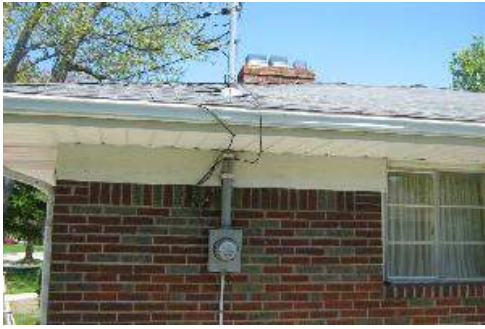
5.1 - COMMENTS: The service entrance is overhead.

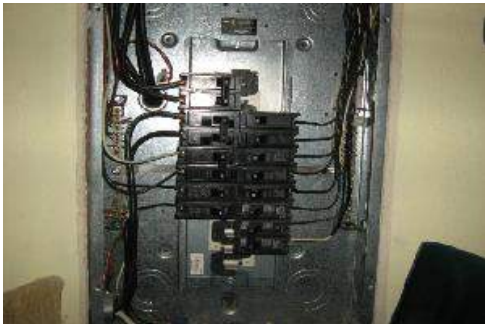
5.5 - COMMENTS: The residence is served by what appears to be a 100 amp panel, located at the right side of the garage

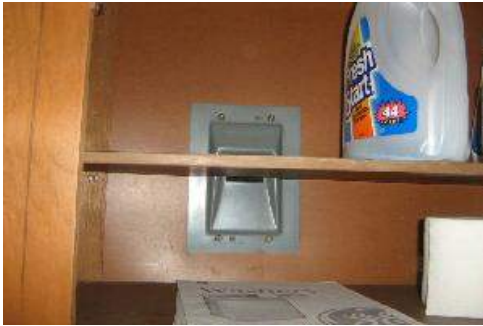
5.9 - COMMENTS: There is a 30 amp sub panel located at the laundry room side of the basement

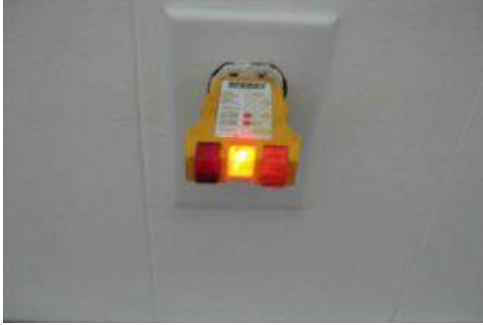
5.22 - SAFETY: There are outlets in the basement (east end) and the basement (west end) that have open grounds that will need to be evaluated by an appropriately qualified specialist and serviced for safe and proper function.

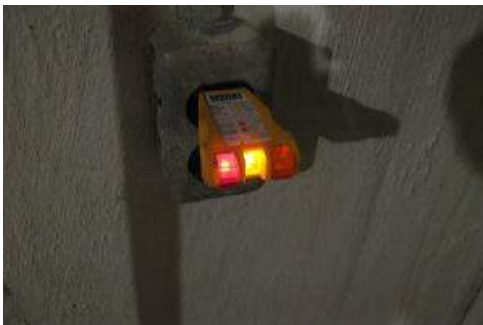
5.23 - SAFETY: There is an outlet in the basement work shop that has reversed polarity (hot and neutral wires misplaced) that will need to be evaluated by an appropriately qualified specialist and serviced for safe and proper function.

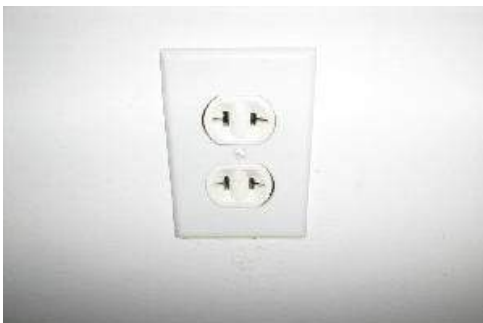
5.24 - SAFETY: Ungrounded 2-pronged exterior receptacle outlets were observed inside the home, which is standard for the period in which the home was built. We recommend, however, that these outlets be replaced with properly grounded 3-pronged outlets as a safety upgrade. In any event, ungrounded receptacle outlets should only be used with appliances that do not require grounding.

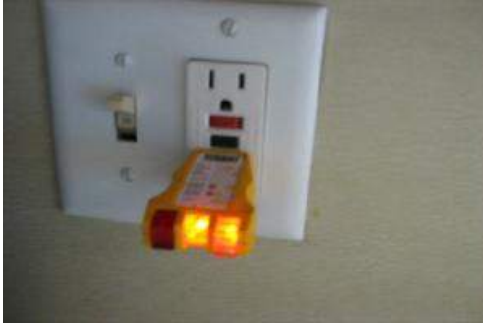
5.25 -- SAFETY: GFCI outlet failed to respond properly

5.25 - SAFETY: The GFCI protected receptacle outlet at the south kitchen counter failed to respond properly when tested using the built-in test button and will need to be evaluated and serviced by an appropriately qualified specialist for safety.

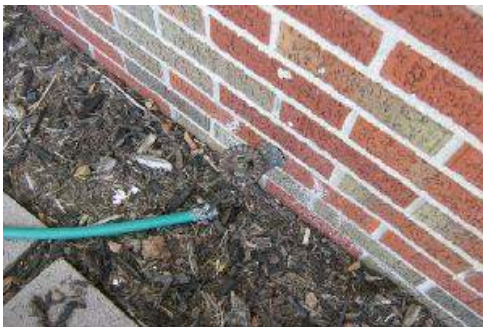
6.5 -- DEFICIENT: Hose bib not functional

6.5 - DEFICIENT: The hose bib at the front side of the home is not functional and needs service.

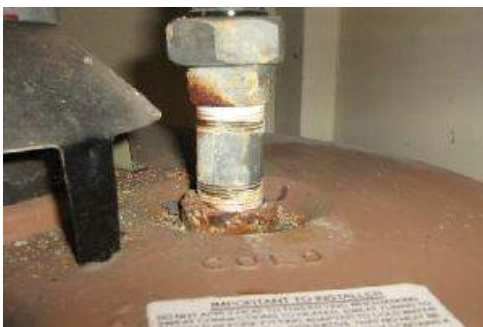
6.18 -- MAINTENANCE: Minor rust or corrosion on pipe fittings

6.18 - MAINTENANCE: There is minor rust or corrosion on the water line fittings, which is not uncommon. However, the rust or corrosion should be cleaned off with a wire brush to insure that the connections are not still leaking.

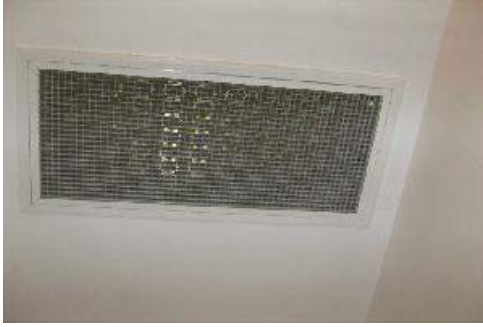
8.1 - DEFICIENT: Air filter is dirty and should be replaced as soon as possible.

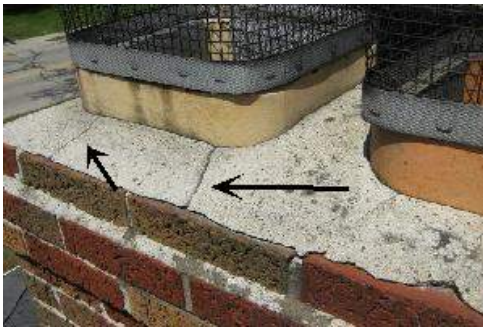
- 9.10 -- DEFICIENT: Chimney crown has cracks that need sealing

9.10 - DEFICIENT: The chimney crown, which is designed to seal the chimney wall and shed rainwater, has one or more cracks that should be sealed to help prevent moisture intrusion.

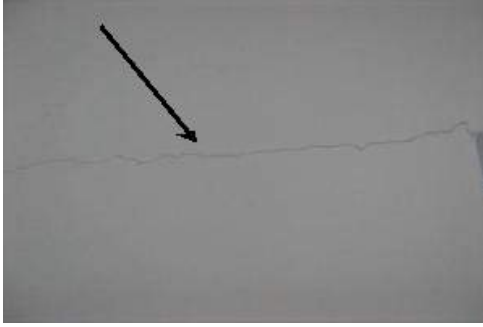
- 10.2 -- COMMENTS: There is damage to the wall covering

10.2 - COMMENTS: There is Minor damage to the wall covering in the kitchen that needs repair.

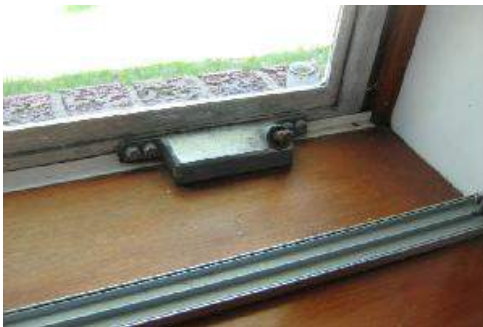
10.6 -- DEFICIENT: Window has broken or missing latching hardware

10.6 - DEFICIENT: A window in the multiple locations has missing crank hardware that will need to be repaired or replaced.

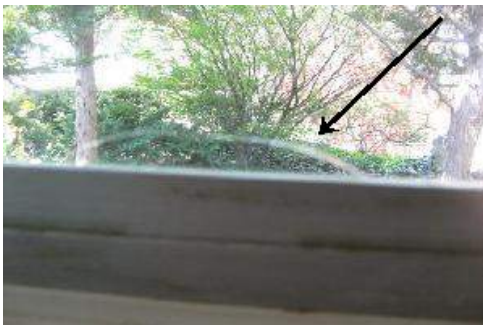
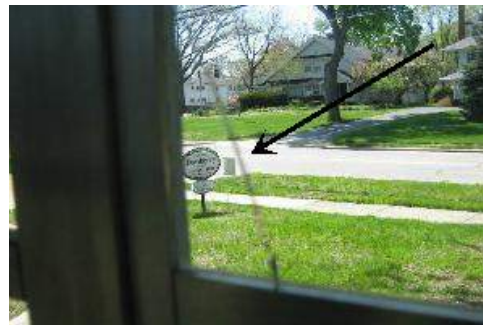
10.8 -- SAFETY: Cracked window needs replacement

10.8 - SAFETY: There is a window in the dining and bedroom that is cracked or broken and that will need to be replaced for safety.
